2 15
LIBBY DAM AND LAKE KOOCANUSA PROJECT, MONTANA

LEFT BANK SLOPE

REPORT DOCUMENTATION PAGE		READ INSTRUCTIONS BEFORE COMPLETING FORM
1. REPORT NUMBER	2. GOVT ACCESSION NO. AD A142 021	3. RECIPIENT'S CATALOG NUMBER
4. TITLE (and Subtitle) Libby Dam and Lake Koocanusa Project, Montana Left Bank Slope		5. TYPE OF REPORT & PERIOD COVERED Final

20. ABSTRACT (Continue on reverse side if necessary and identify by block number) Report details the geology and history of the Libby Left Bank Slope instrumentation program, presents plots of instrumental data for the period 1967-1983 and provides a technical evaluation of the present status of the slope.

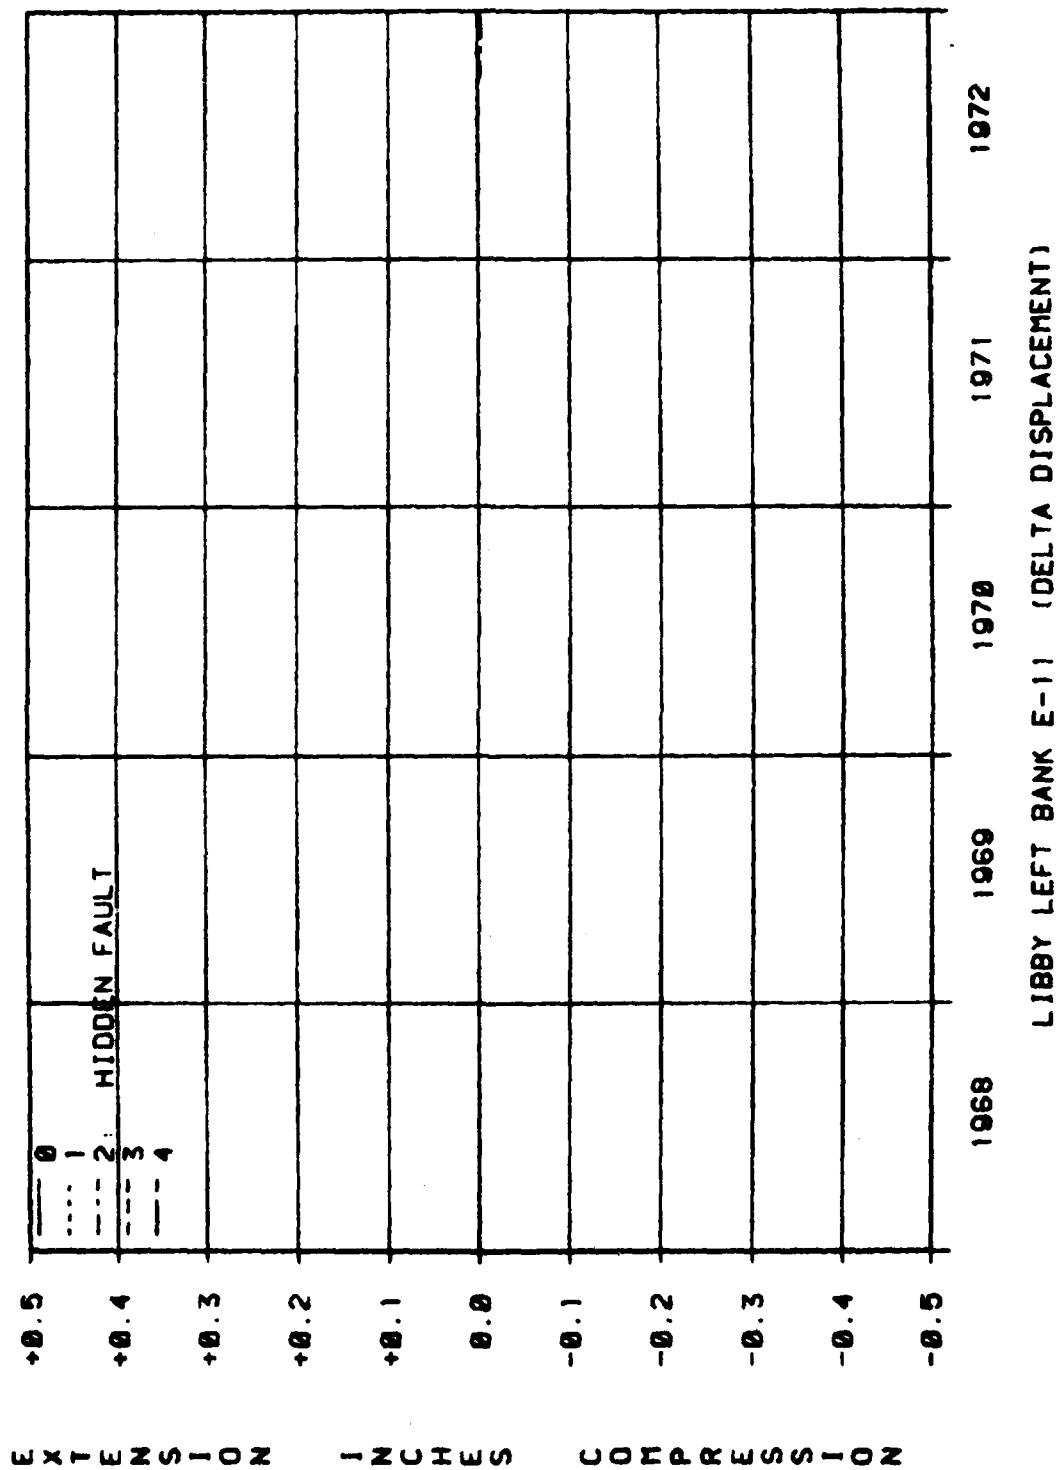
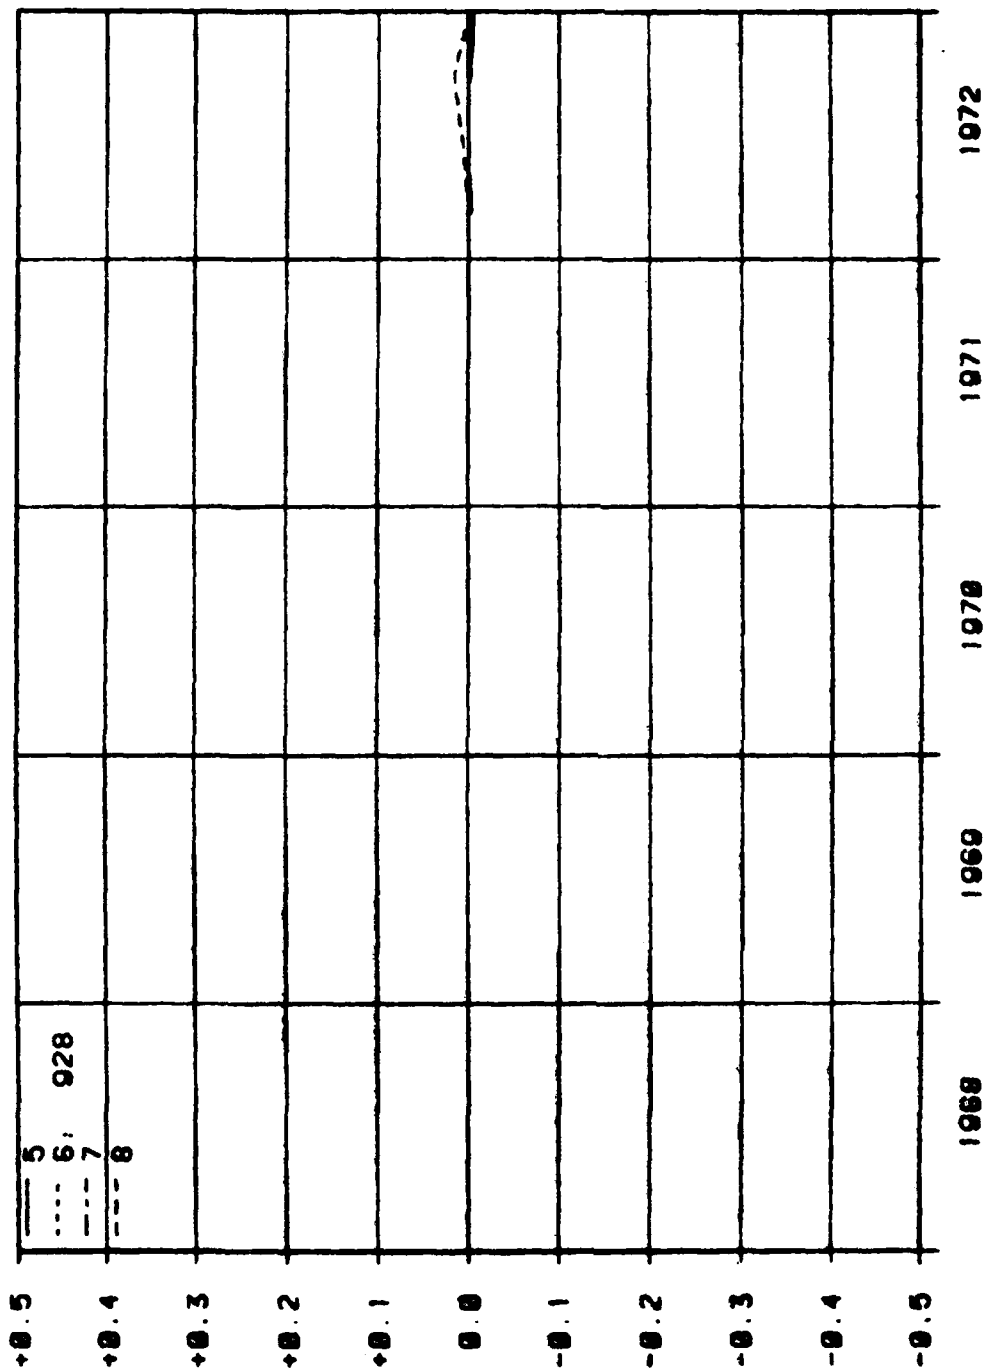
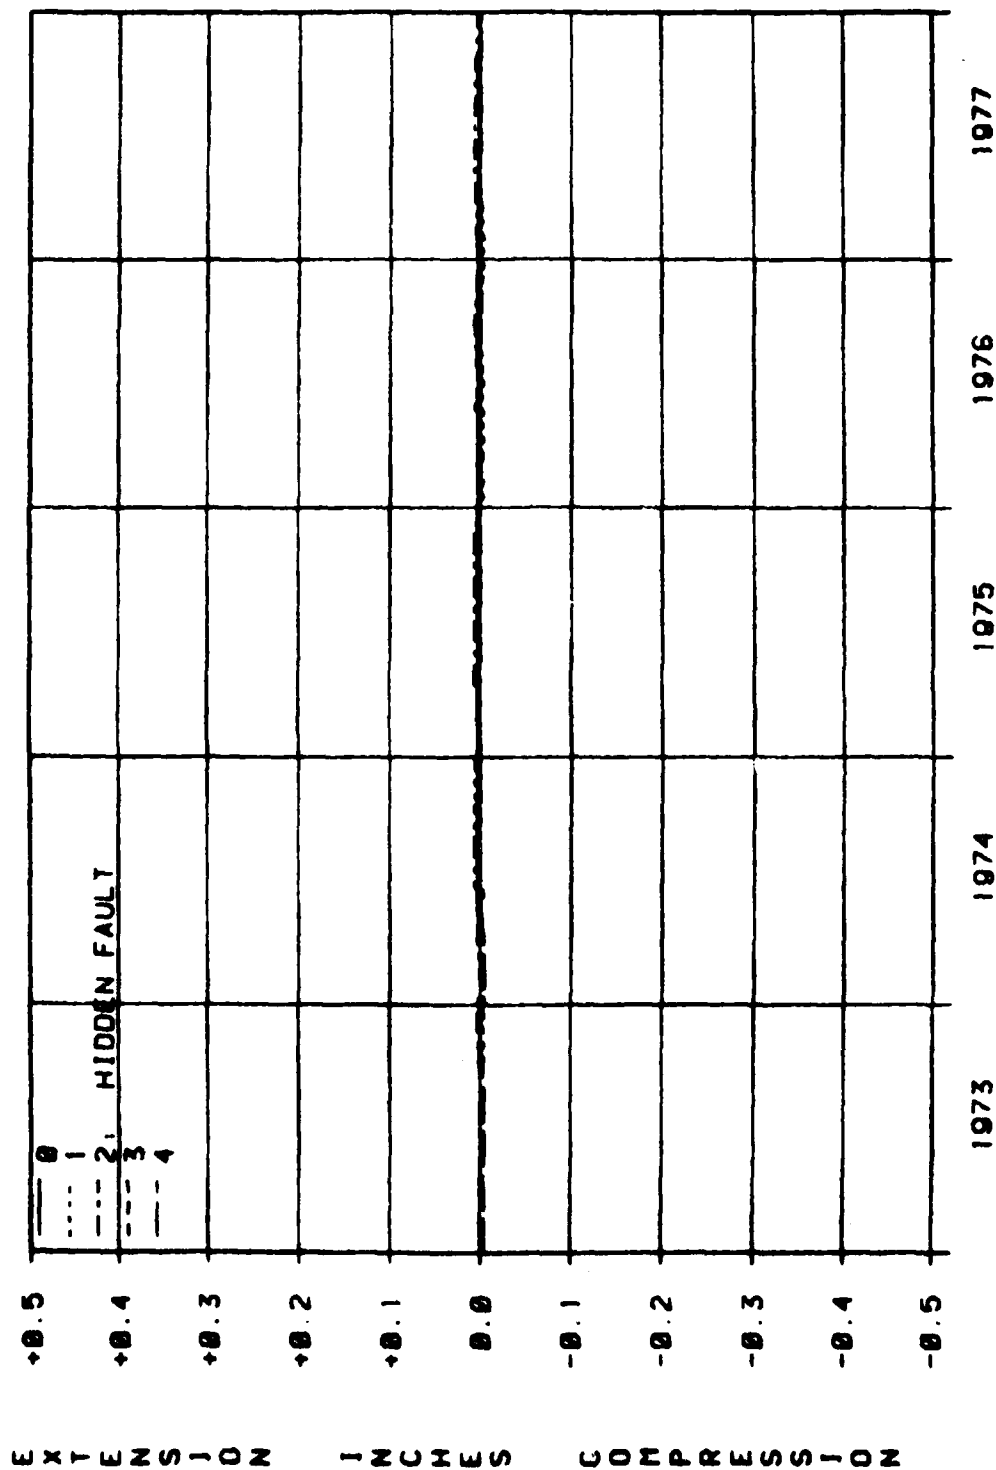
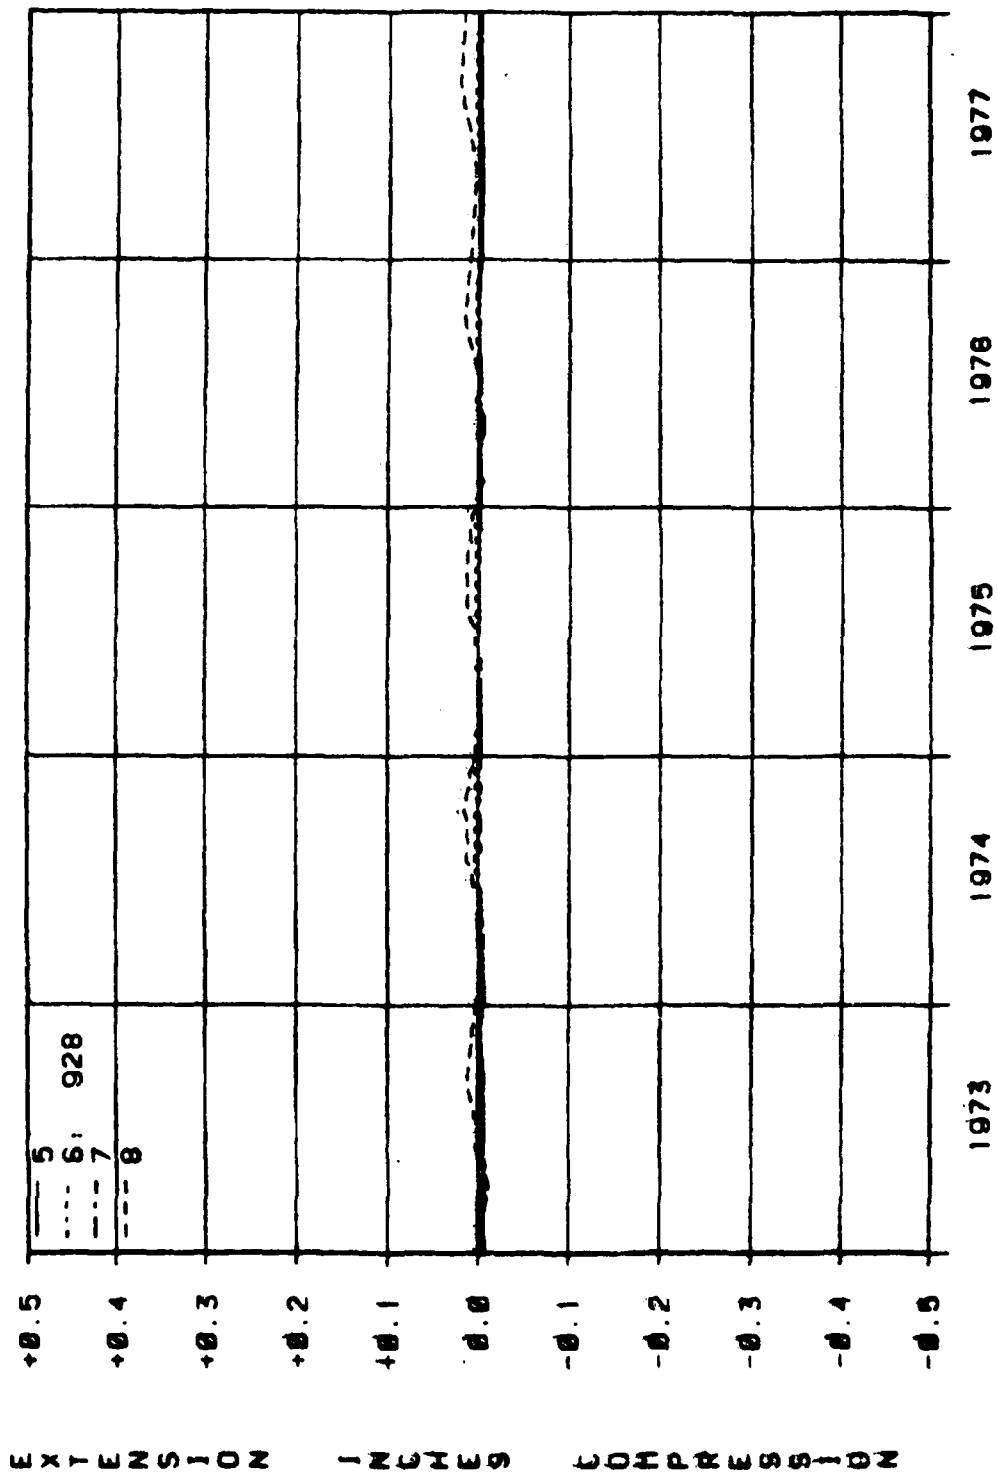
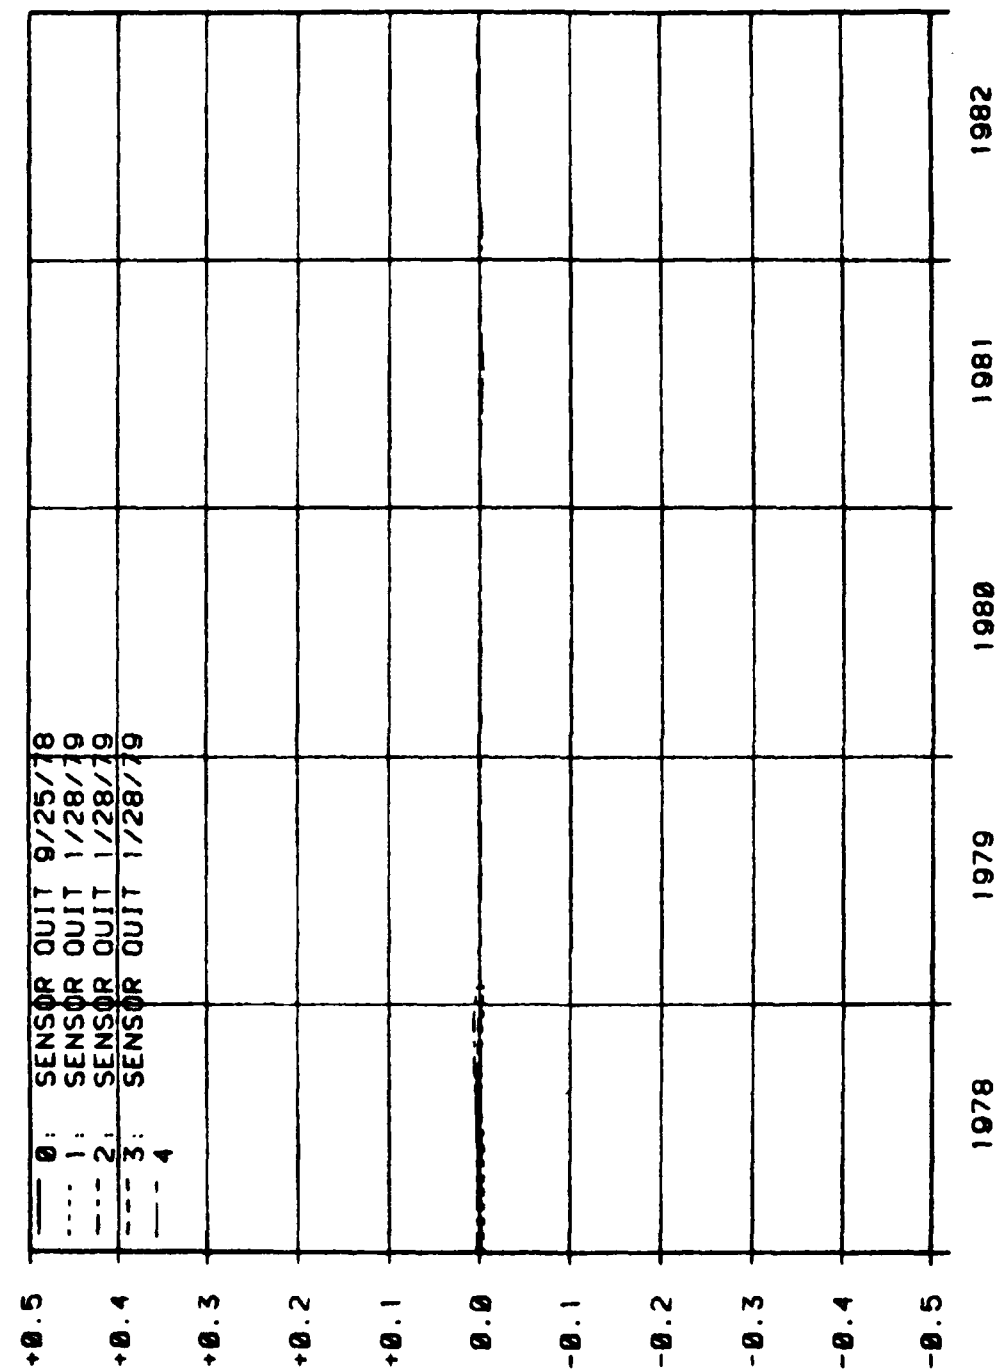
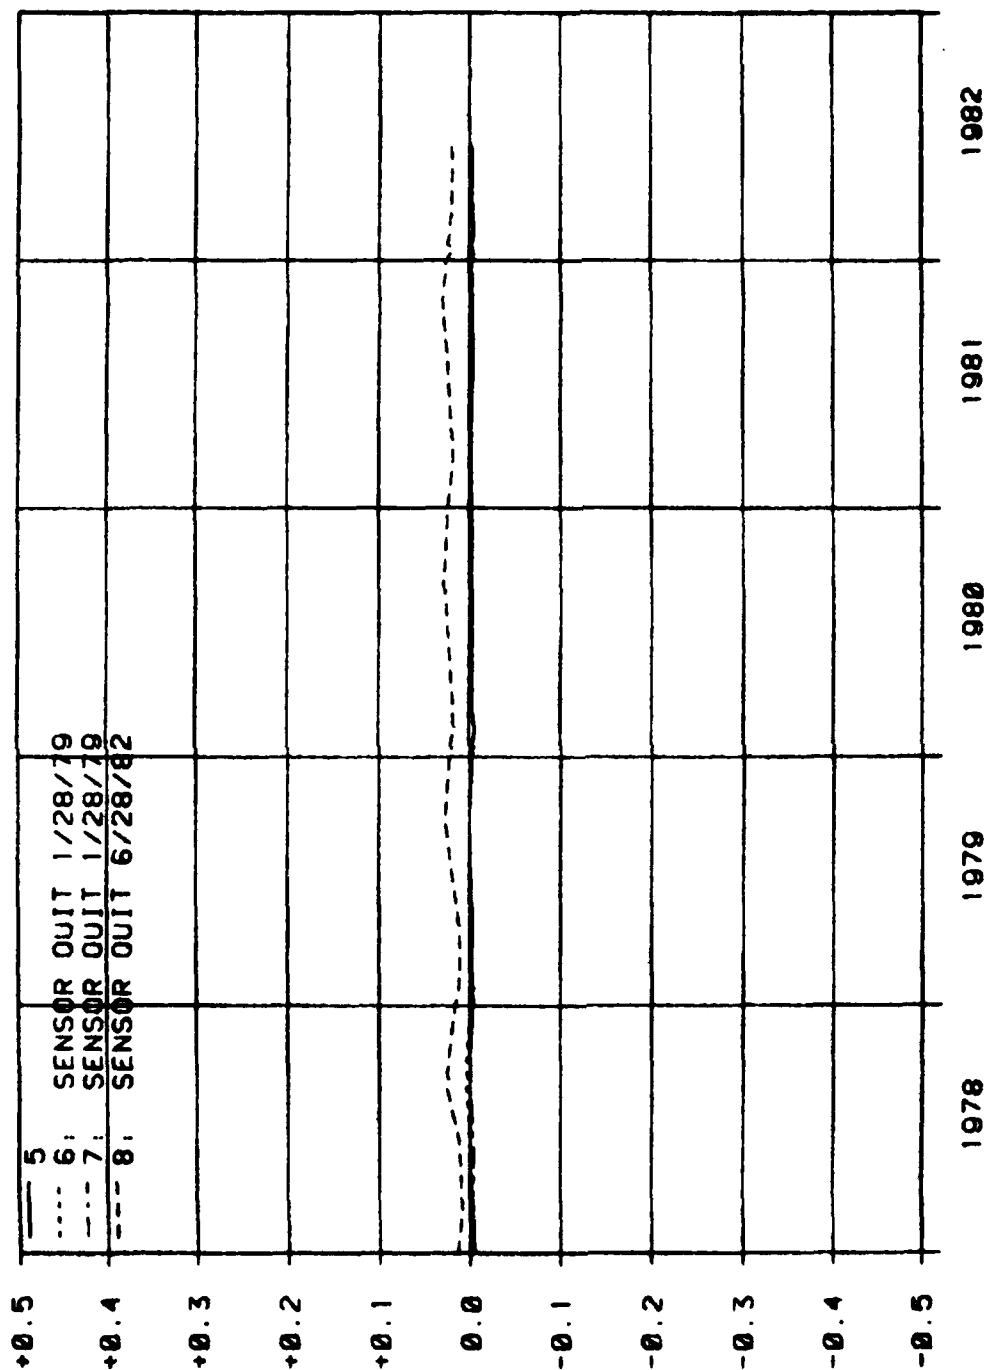
LIBBY LEFT BANK E-11 (DELTA DISPLACEMENT)

c. Extensometer Analysis. On the 928 Bedding Fault, the shallowest of the three major faults in the rib, the small amount of borehole compression (E-1-7) in mid-1972 may be either downslope movement or actual consolidation due to construction activity (figure 4.15a). No further activity is noted. The Hidden Bedding Fault showed a minimal compression at the toe, accumulating mostly in 1973 (figure 4.18b), but has been stable since. The 930 Bedding Fault exhibited stability until late in 1981. The two lower sensors of E-1 (E-1-1 and E-1-2, see appendix C), the latter of which crosses the Hidden Bedding Fault, showed extension on the order of 0.08 to 0.18 inch at this time, while the totalizer (E-1-0) showed compression on the order of 0.05 inch. The opposing reaction appears to be an instrumental problem, casting some question on viability of further data from the instrument. Early in 1981, E-1-8 showed compression on the order of 0.04 inch, indicative of downslope movement of a surficial block. This movement was not directly substantiated by the totalizer which may no longer be a viable sensor. The most well documented motion in this rib was during the period 1973 to 1976, beginning with the second pool rise, when the near surface sensor at the toe of the rib, E-1-8, indicated compression on the order of 0.3 inch, suggesting a downslope slip on a shallow, unnamed bedding fault of about 0.6 inch (appendix C, E-1 plots). No further evidence of slippage was noted after the 1976 pool rise. Seasonal cyclic motion in response to ambient temperature changes in the surficial rock mass high on the slope is seen on both E-10 and E-11.

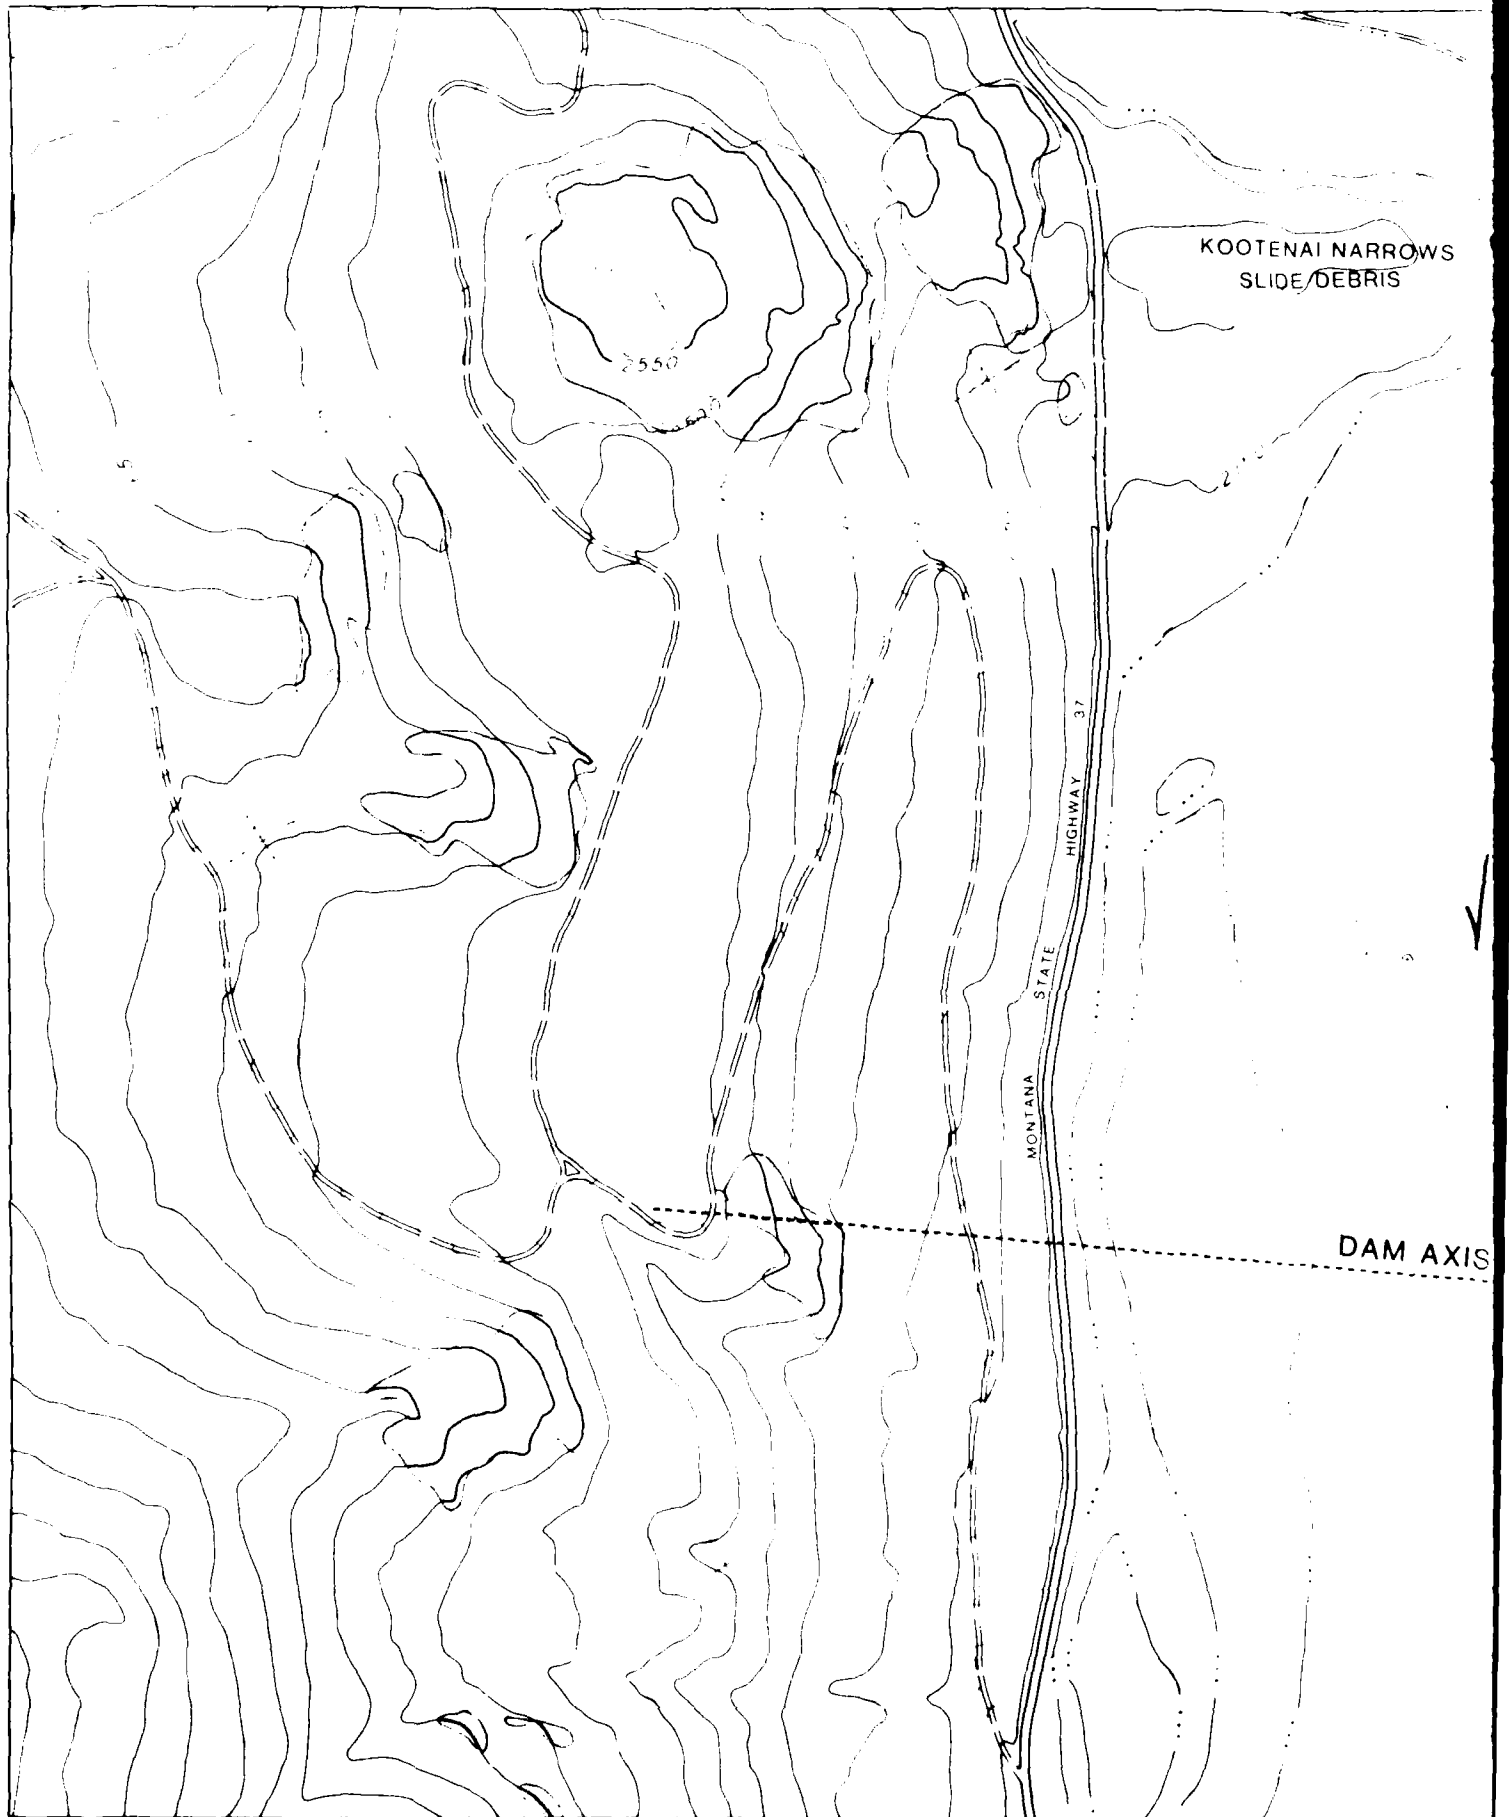
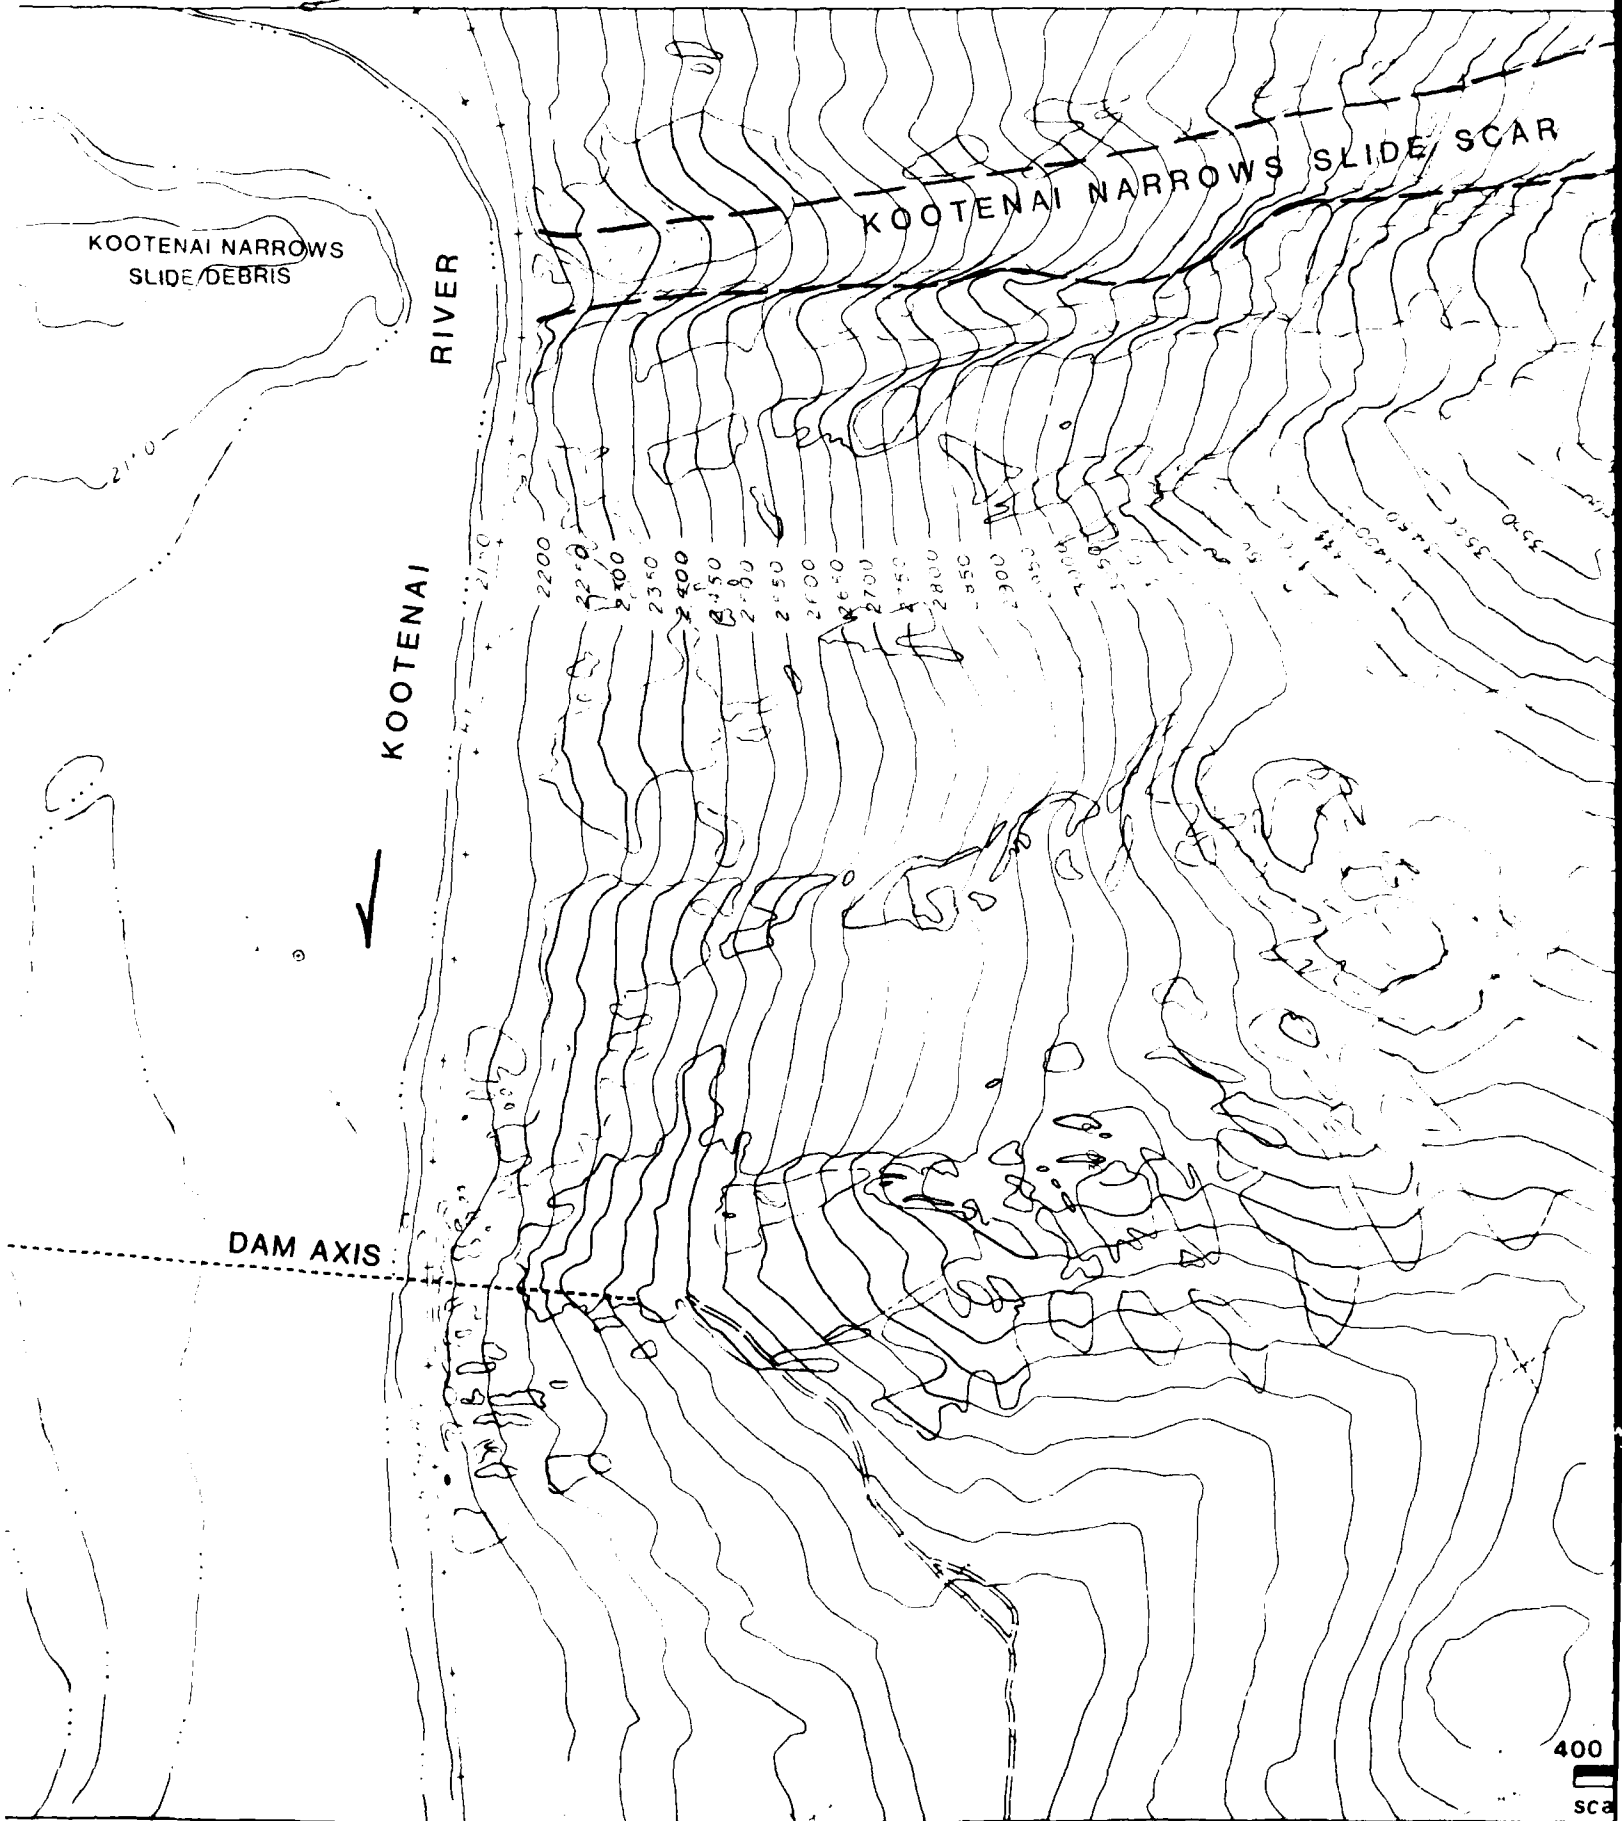
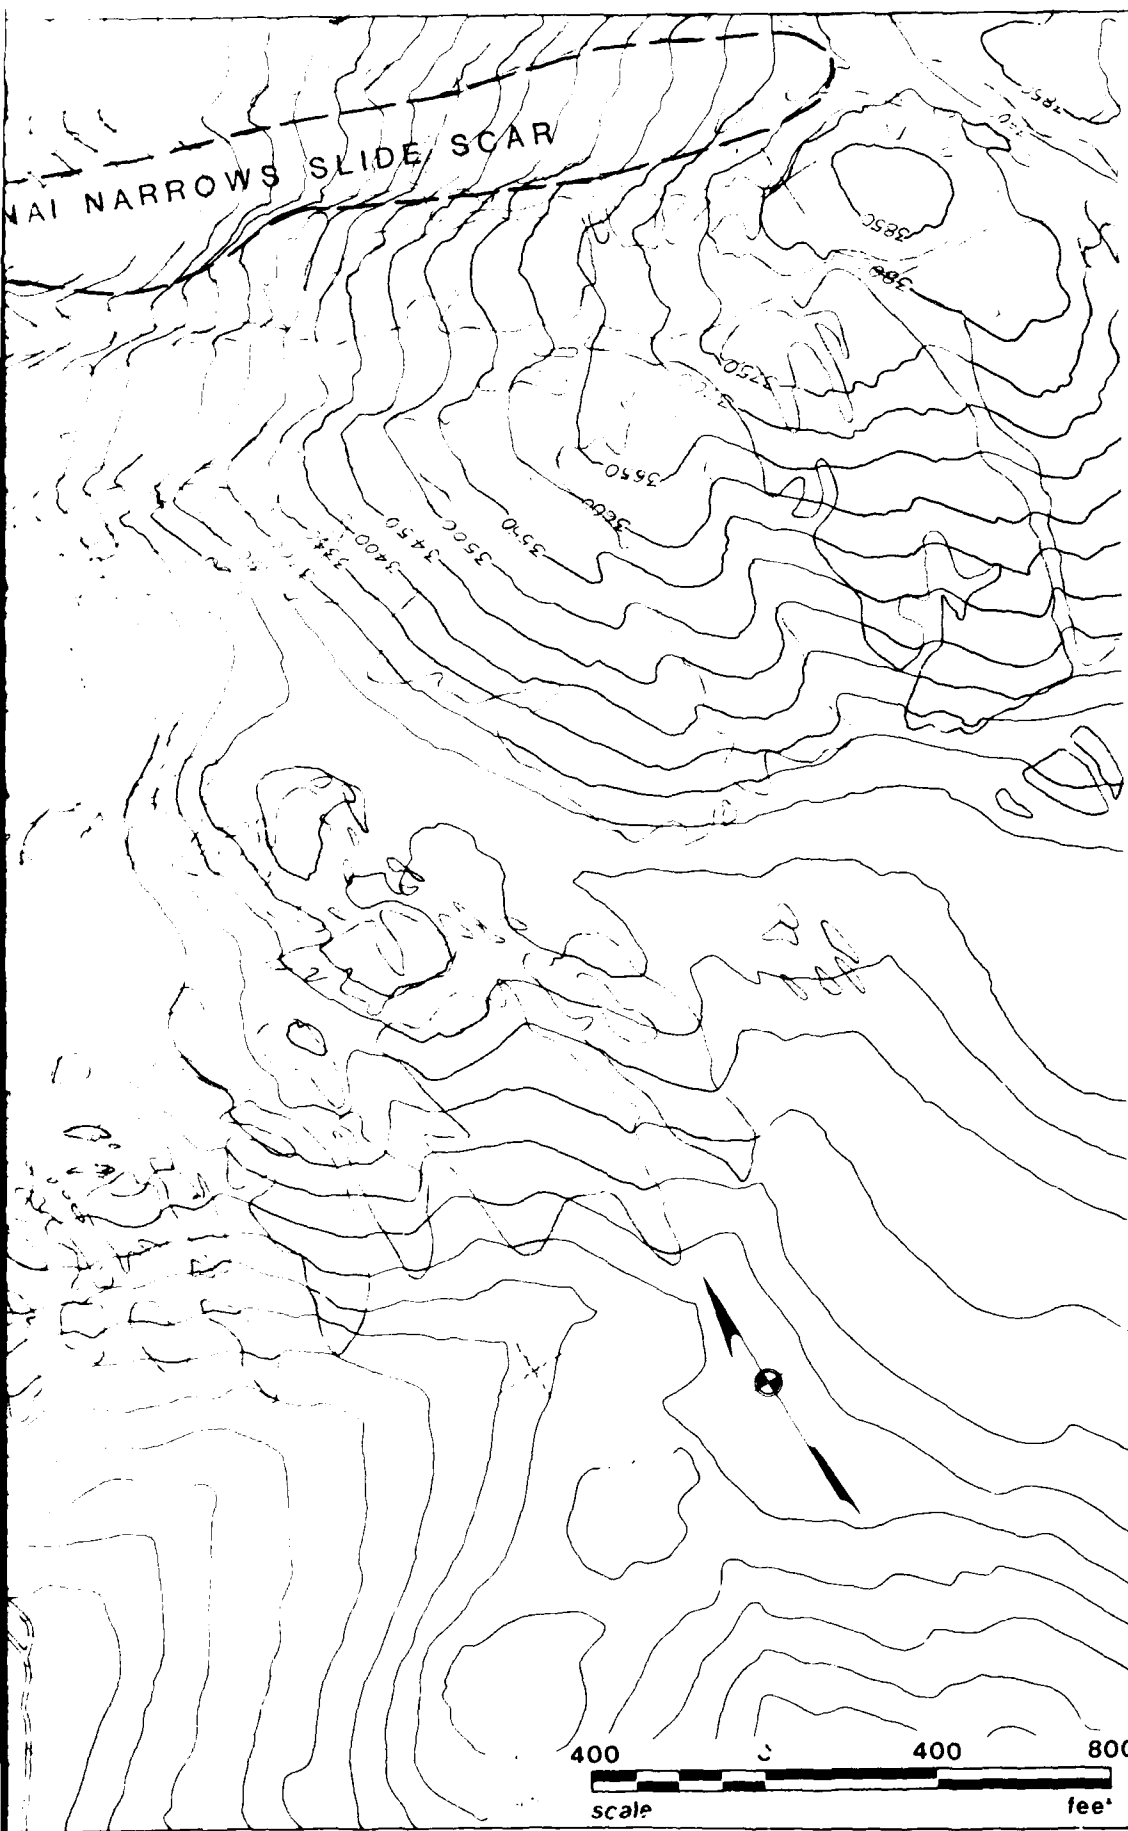
PLATE 1

2.04 Kootenai Narrows Slide. A unique constriction in the Kootenai Valley was evident at R.M. 219.5 about 1/2-mile upstream from Libby Dam prior to the raising of Lake Koocanusa (plate 1). The morphology of the feature, its constituent materials, and the geologic structure and topography of the adjacent left valley wall led to the conclusion at an early stage of geological investigation that the feature originated as a major rock slide. The feature consists of a debris pile of rock blocks and rubble locally mixed with gravel and partly mantled by silt and sand. The original shape of the rubble pile fanned westward, and the prereservoir channel was close against the toe of the left (east) valley wall, presumably the low point in the rubble pile. The high point of the rubble pile is at elevation 2,220 feet near the toe of the right valley wall. The base of the rubble pile is about elevation 2,075 feet beneath the prereservoir channel. The trough from where the rubble originated rises from elevation 2,150 feet at the toe to 3,300 feet at the top in a distance of about 2,000 feet. The trough was formed by a major bedding fault and an east-west fault with the plunge of the intersection estimated at 29 degrees toward the valley. Depending on the assumption of preslide topography, the volume of the slide is estimated between 1.75 and 2.5 million c.y. The configuration of the rubble pile and its position in the valley indicates that it was a high velocity slide. The slide velocity has been estimated as between 62 feet/second and 155 feet/second. The date of the event is not certain. It is clearly postglacial and prehistoric. The river was essentially at its present grade so that the event probably occurred not more than a few hundred years ago. Investigations at the toe of the trough show that the trough was not entirely undercut by the river and that failure required shearing through the rock mass or release along preexisting joint sets. It is possible that the failure was timed by a seismic event. This feature has provided an excellent field laboratory to study the future potential effects of Left Bank Slope failures.
